# Case Study: Assessment of the Existing Condition of Road Side Drainage Structure, Wolaita Sodo Town, SNNPR, Ethiopia

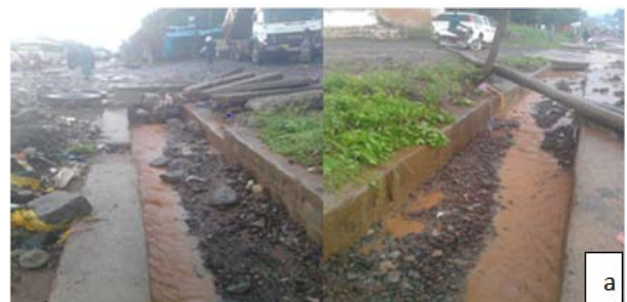
**Figure 3:** longitudinal drainage blocked by solid waste, Construction materials (Cobble stones, masonry), sediments: (a) In front of TAF fuel distributor , (b) Back of TAF fuel, (c) Infront of Bilal Mosque gate.

The road under construction [Fig. 3, b], pavement edge [Fig. 8, c and d], cobble stone roads and houses [Fig. 8, a and b] were eroded by the runoff.

According to [13], high amount of solid wastes are disposed in this town per a year. So that, the runoff problem happened due to blockage of drainage by solid wastes, construction activity and absence of cross drainage structures. Another very important factor collected from site over survey was, the cross section of the drainage could not constructed properly to accommodate the maximum probable discharge without damage on it [Fig. 3 and Fig. 6, c and d].

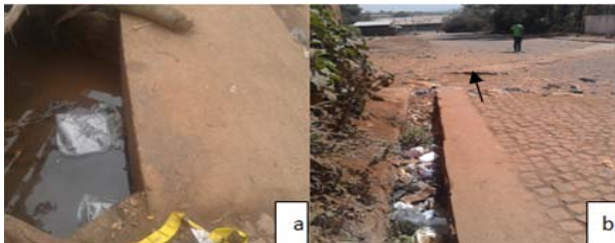
**Figure 4:** Cross drainage filled by sedimentation and solid wastes; (a) on the route bus station gate to Maedot (b) Back of US College.

Furthermore, the roadside ditches cross drainage and culverts are filled by rocks and sediments [Fig. 4, a and b]. The gullies, debris and Solid wastes are also major materials which block the ditches in study area. The periodic removal of this material is

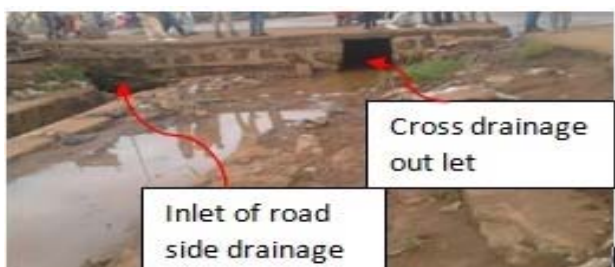
The joint in between outlet of cross and inlet of longitudinal drainage structure is not properly designed and installed [Fig.5].

**Figure 5:** Cross and longitudinal drainage structure (near to bus station)

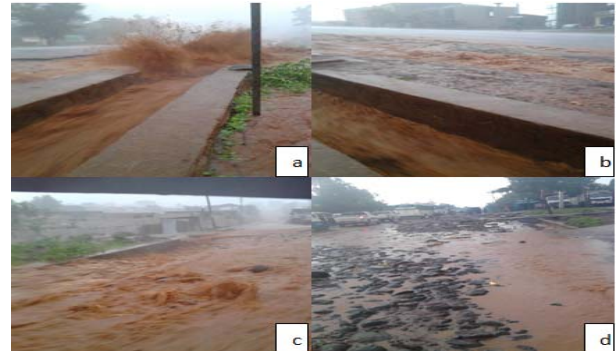
According to [12] the dominant soil type found in Wolaita sodo town is silt. These soils are categorized under fine grained soil and have low permeability. Because of this, nearly all rain falls on the ground converted in to runoff.

**Figure 6:** Runoff flow over the road.

The images shown in Fig.6 (a) and (b) were located in front of Dashen bank Tona branch. Fig.6 (c) and (d) were located on the cobble stone road in front of Dashen bank Tona branch to prison, and in front of TAF fuel respectively.

The greater the slope the more surface runoff and less soil absorption. Conversely, the lesser the slope the more soil absorption and less surface runoff are experienced [10]. In flat or slightly undulating terrain one would aim to achieve a longitudinal gradient between 2 and 5 percent (1:50 and 1:20) in the drains. With gradients less than 2 per cent, silting occurs easily while with gradients steeper than 5 percent the ditches will easily erode [6]. In fact, the gradients of most of the distances covered in this route are greater than 5 percent. Because of these, more surface runoff was happen. The route from TAF fuel to the gate of Sodo ATVET College has the slightly undulating terrain. That is why the drainages were filled by sediment and gullies [Fig. 3, a]. The runoff left rocks and gullies on the pavement and free movement of vehicles was affected [Fig. 6, d].

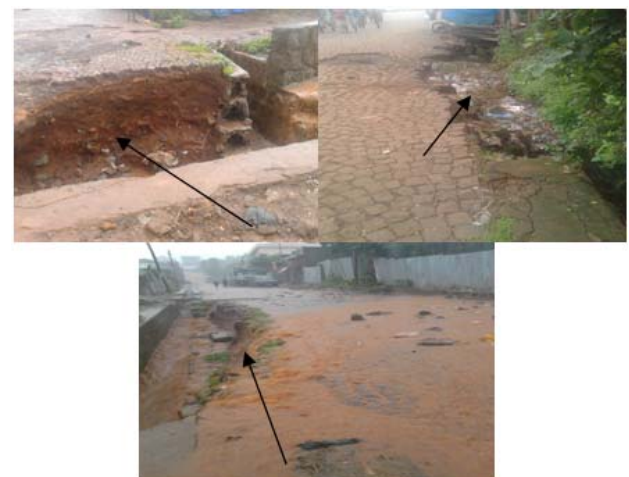
The steep Slope of longitudinal drainage has high scouring impact on the bed and cross section of the ditch. Fig.7 'b, c, d' and 'a' are found in front of Dashen bank Tona branch and road under construction at the back of TAF fuel respectively.

**Figure 7:** Damaged road and drainage.
